Rapid visual screening of building for potential ground movement in Kalirejo, Kulonprogo, Yogyakarta

Sely Novita Sari^{1*}, Rizqi Prastowo², Rahmad Junaidi³, Amir Machmud⁴

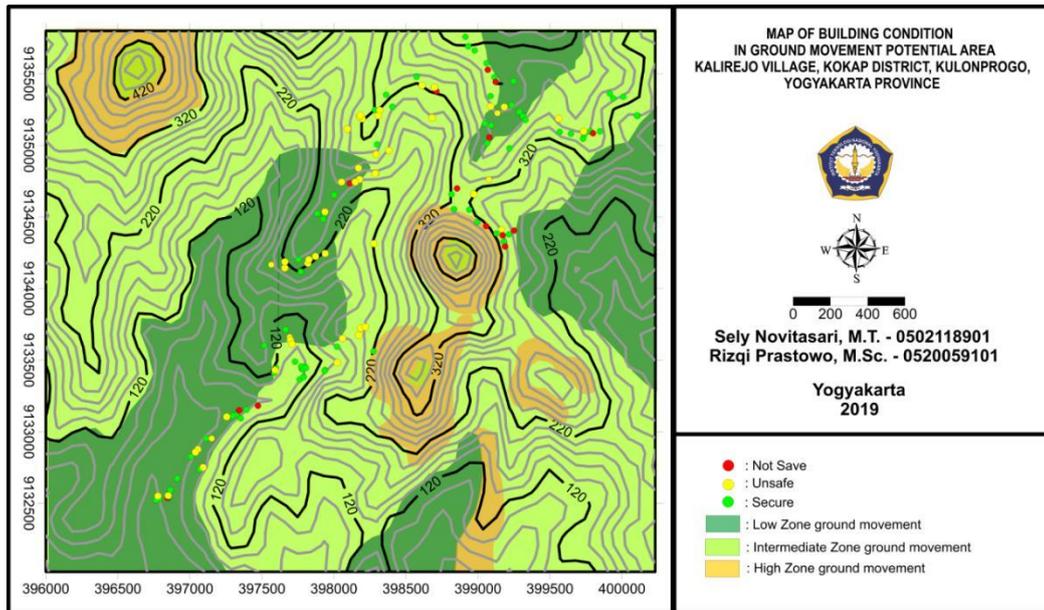
Figure 3. Map of Building Condition of Sample Site at Kokap District, Yogyakarta, Indonesia

The survey was carried out following the agreed coordinates with the reference coordinates using a map of potential building strength in the Kalirejo area, as shown in Figure 3. The surveyor started building appraisal by filling out a simple building appraisal form following the coordinates agreed upon previously (Sjaifuddin et al., 2019). How to analyze it by looking at the answer Yes with a value of 1, the answer Less with a value of 0.5, and the answer is not the value of 0.

The results of the calculation of the building score (Table 2) obtained the value of the condition of the entire building that has been surveyed. In table 2 is a recapitulation of building score results (and the coordinates of his home field) from the evaluation of

simple buildings in the four hamlets in the Kalirejo area. Building conditions are obtained by following the conditions index scale according to table 1 and giving color to each building category. Green color for safe building conditions with building conditions

index value is 70-100%, yellow for unsafe building conditions with building condition index values 40-69%, and red for unsafe

building conditions with building condition index values 0-39 %. Building classification in the form of color can be seen in figure 3.

10.42% of buildings that have to be considered because of the insufficient building conditions, resilience, and in areas prone to landslides. It is recommended to make a map of the distribution of potential damage to buildings with a map of the potential for existing land fractures so that it can be input for local governments and communities to conduct pre-disaster mitigation.
